Hong Kong University of Science & Technology

Outdoor Swimming Pool

Case Study

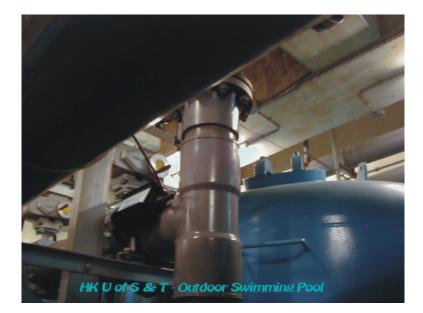
Three HydroPath units were installed. The ozonator was switched off and the carbon filters were by-passed.

With the assistance of HydroPath, the free chlorine dosage was maintained at 1ppm even without the ozonator and the University now extended the backwash frequency to once a month. It was noticed that the chlorine usage was reduced by 30%. Without the ozonator, there was no need to maintain air conditioning in the pump room. It was estimated that the university **recovered its investment within 9 months.** The pool water was tested weekly and no bacteria were found.
